# Pedestrian/Bicyclist Warning Devices and Signs at Highway-Rail and Pathway-Rail Grade Crossings

**Paul Metaxatos and P.S. Sriraj**

CUTR Webcast • June 12, 2014

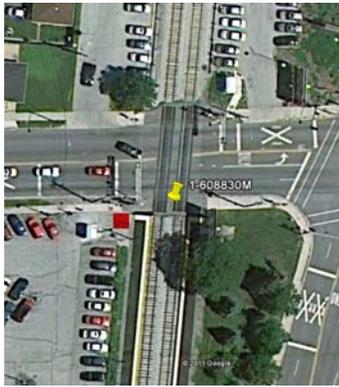
Camera location at the crossing on 119<sup>th</sup> Street in Chicago.

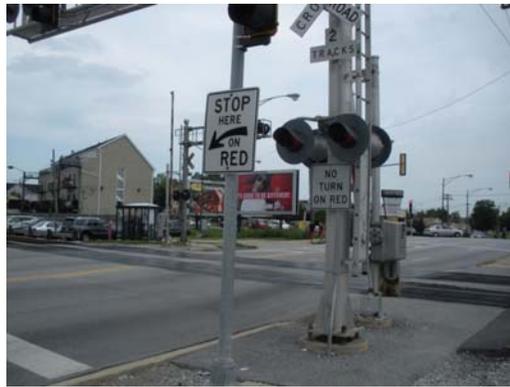
Crossing 608830M – A view from the ground.

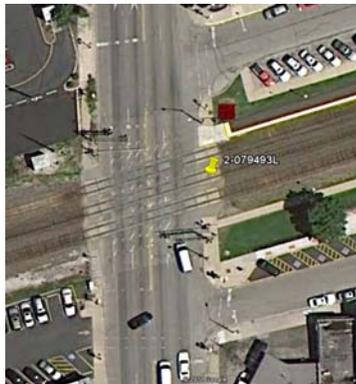
Camera location at the crossing on Harlem Avenue in Riverside.

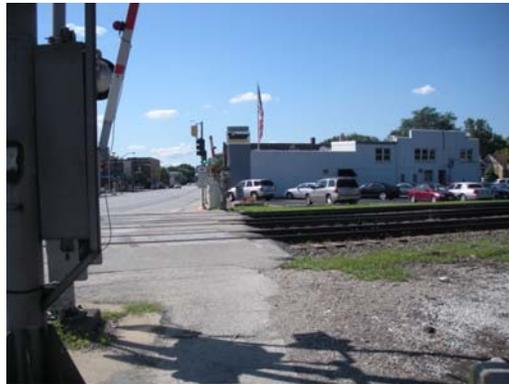
Crossing 079493L – A view from the ground.

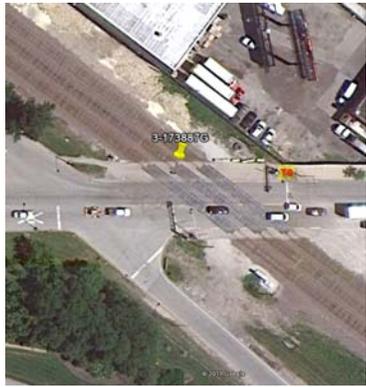
Camera location at the crossing on Nagle Avenue in Chicago.

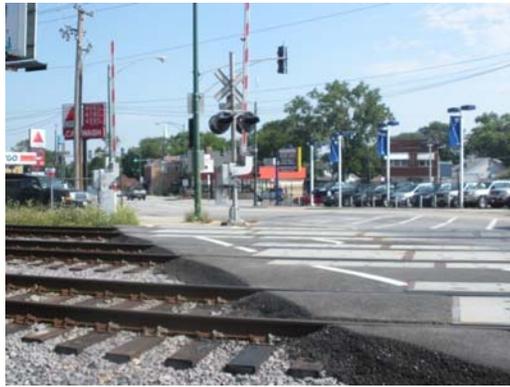
Crossing 173887G – A view from the ground.

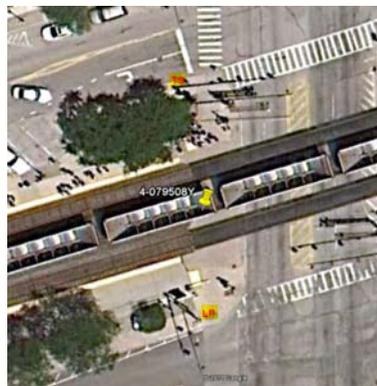
Camera location at the crossing on LaGrange Road in LaGrange.

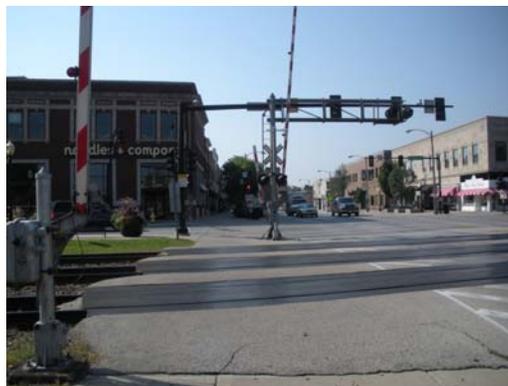
Crossing 079508Y – A view from the ground.

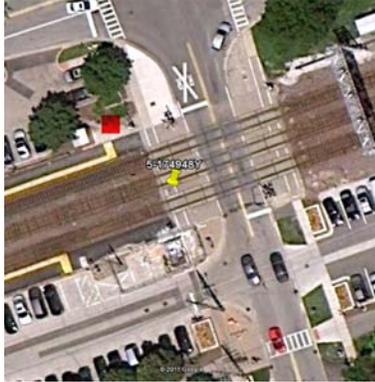
Camera location at the crossing on Park Boulevard in Glen Ellyn.

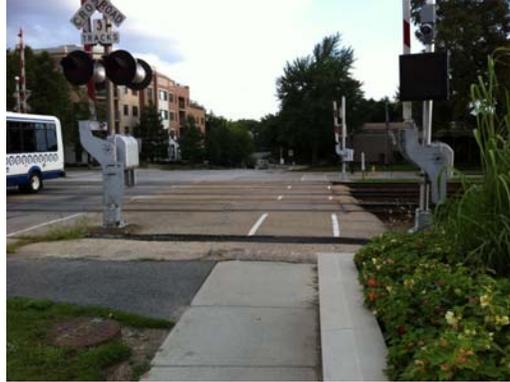
Crossing 174948Y – A view from the ground.

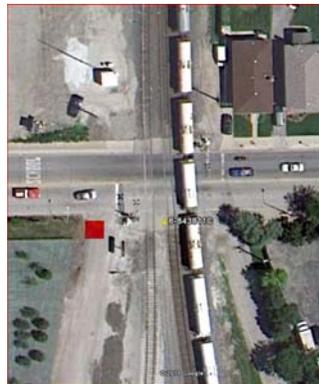
Camera location at the crossing on Marquette Road in Chicago.

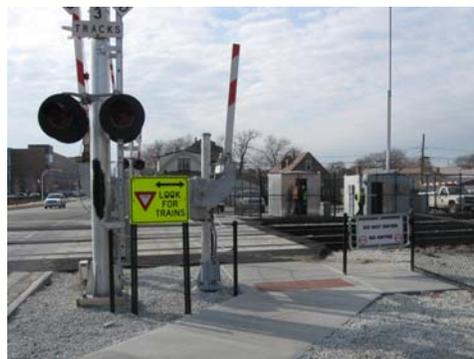
Crossing 843811C – A view from the ground (courtesy of ICC).

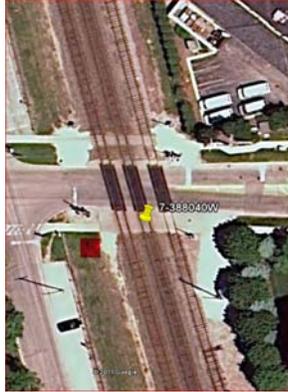
Camera location at the crossing on Osterman Avenue in Deerfield.

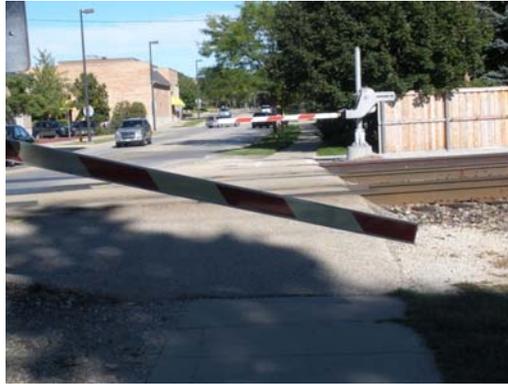
Crossing 388040W – A view from the ground.

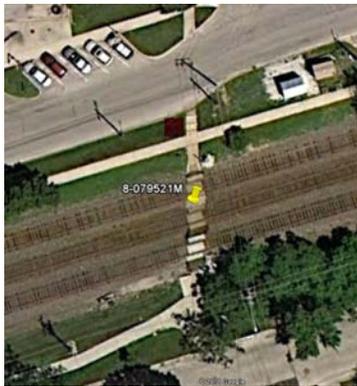
Camera location at the crossing on Park Street in Hinsdale.

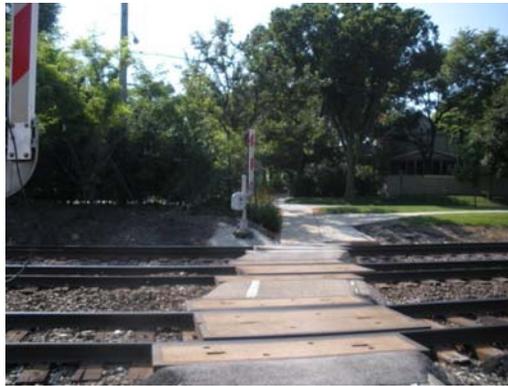
Crossing 079521M – A view from the ground.

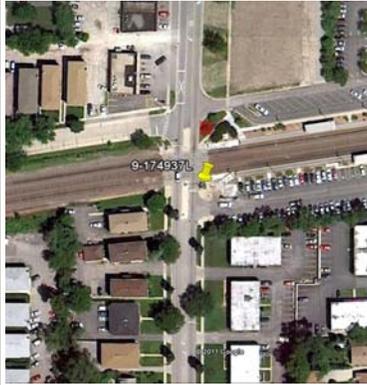
Camera location at the Villa Park Depot crossing in Villa Park.

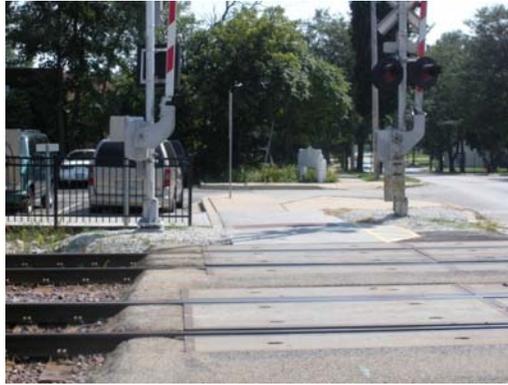
Crossing 174937L – A view from the ground.

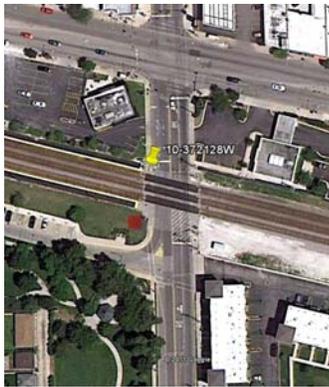
Camera location at the Elmwood Park Depot crossing in Elmwood Park.

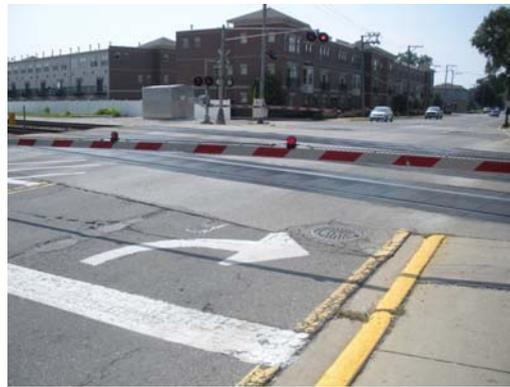
Crossing 372128W – A view from the ground.
