Traffic Signs Research Study for Miami-Dade County

Executive Summary

Miami-Dade County

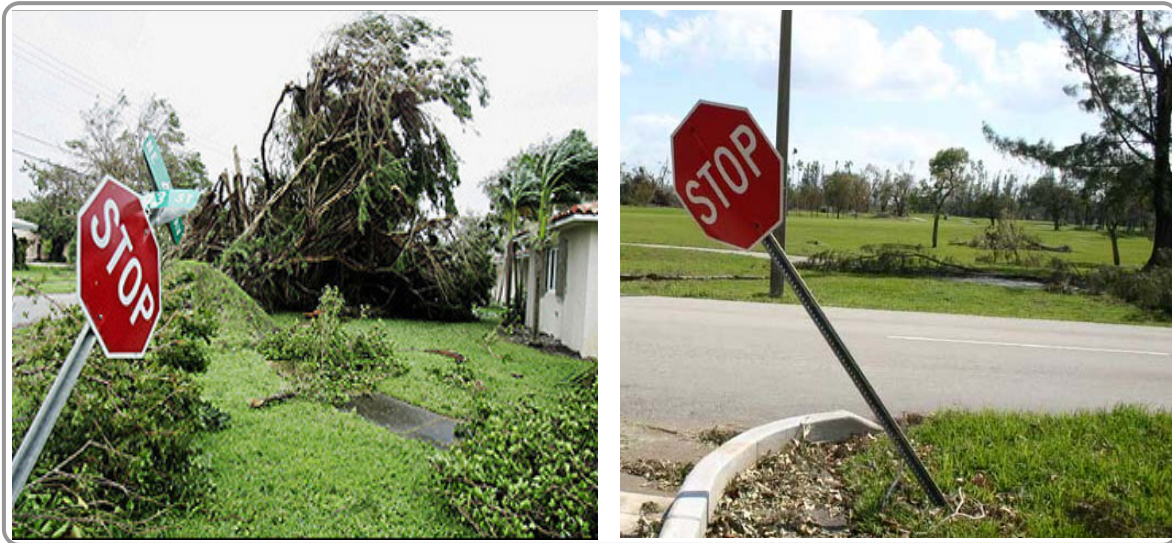
Figure A: Stop signs damaged in Miami-Dade County during Hurricane Wilma

The years 2004 and 2005 were very active regarding hurricane activity in the Atlantic basin. Miami-Dade County experienced damages due to hurricanes Katrina and Wilma within a time span of barely two months. A significant proportion of street signs failed when these two hurricanes impacted Miami-Dade County and its surrounding communities. A traffic sign is considered as failed if it is leaning by more than 15 degrees from its vertical axis. Most of the street signs failed at their foundations, as shown in Figure A. This fact raised the need to find effective alternatives to secure traffic signs and reduce the number of damaged signs during moderate hurricanes. By improving the wind force withstanding capability of street signs, the costs associated with their repair and/or replacement are considerably reduced and the county's valuable resources can be concentrated towards other aspects of the recovery process.
